October 6, 2010

RE: 545 W. Adelyn Drive- Wilson Reservoir

Wilson Reservoir-Tree Data

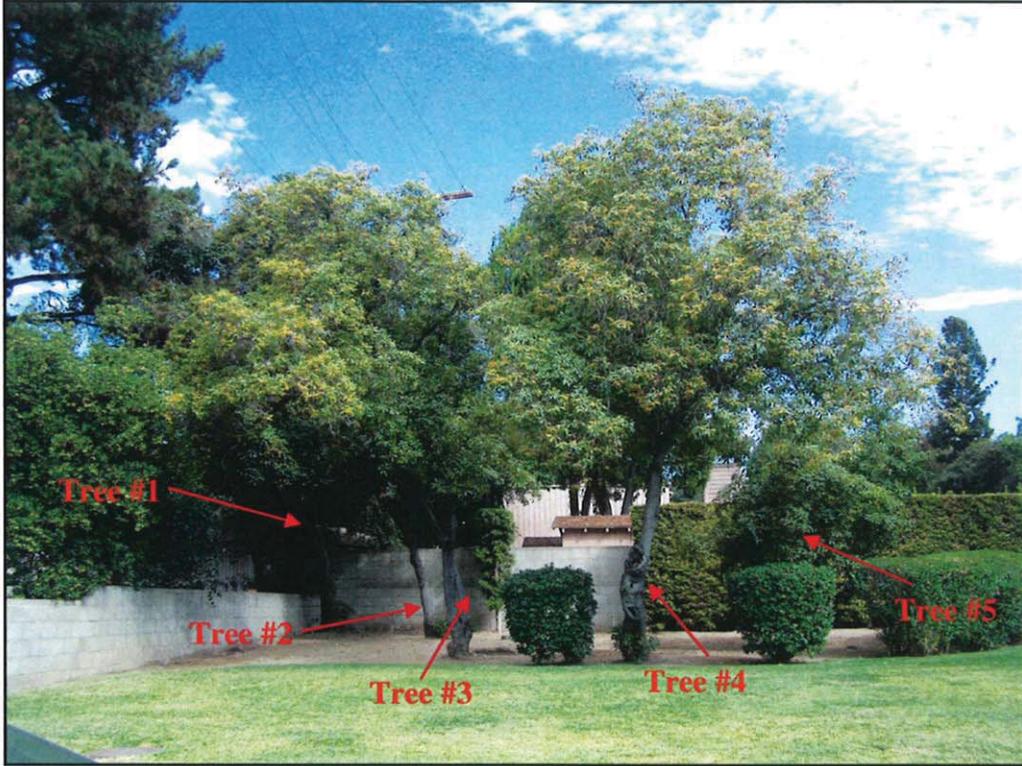
DISCUSSION: The project detail calls for the removal of seven trees within the property boundary: 5 Victorian Box trees located in the dirt planting area at the front of the property, and 2 Oriental Arborvitae trees located just inside the fence area. All the Victorian box trees show signs of dieback and decline, with several having significant amounts of decay present (see Figures 1-3). The arborvitaes are relatively healthy, however a new operations building is planned for the area where they are now growing and their removal is needed to facilitate the new construction. Neither of these trees is listed as a Class I tree, and they may therefore be removed without special permit.

Figure 1. Showing the five Victorian Box trees planned for removal, All of these trees are of low vigor with various levels of decay as well as canopy wide dieback.

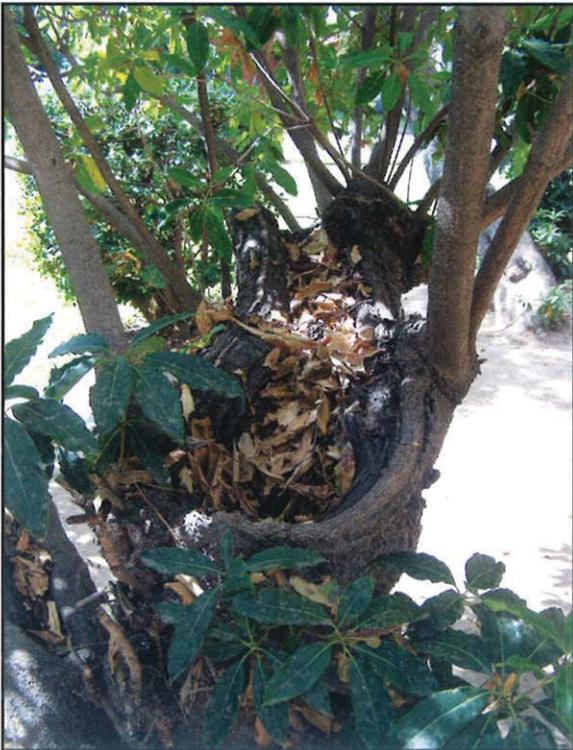
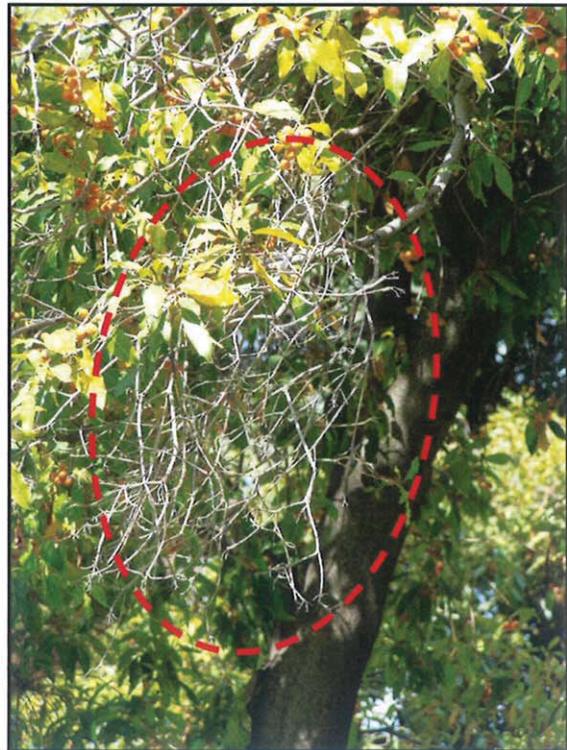
Figures 2. & 3. Showing examples of the decay and canopy decline found on all of the Victorian Box trees.

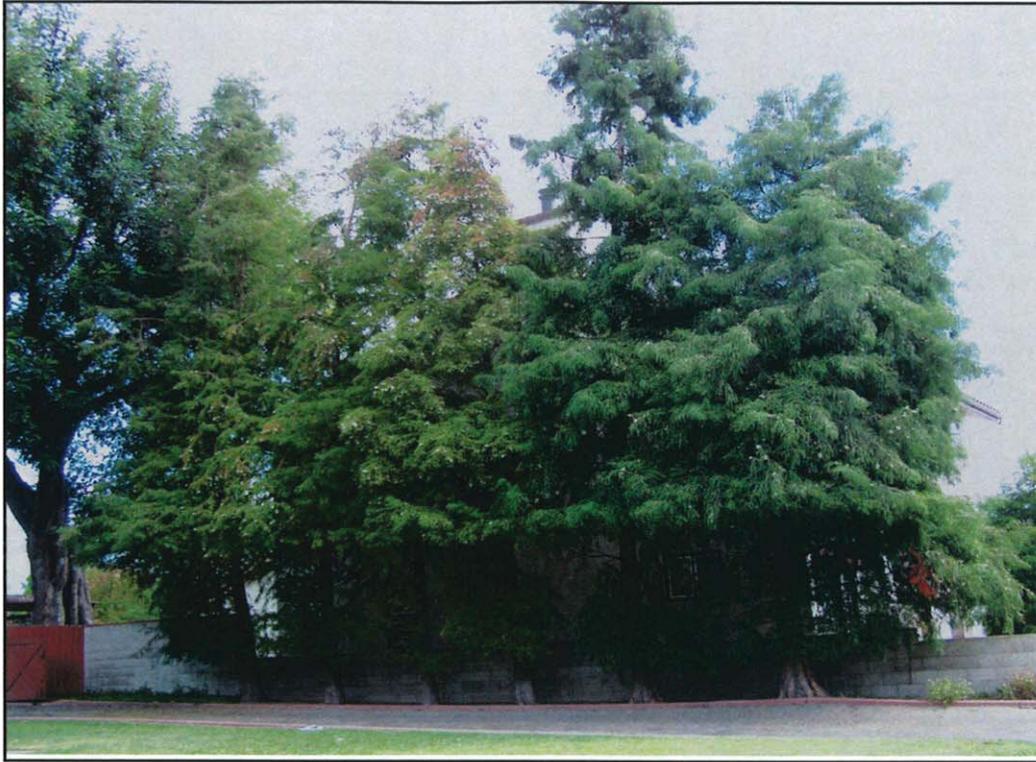
Figure 4. Showing the row of six Bald cypress trees which are to be retained on the site. The driveway will be moved and the growth space enlarged. All of these trees are healthy with good vigor and should continue to thrive on the site.

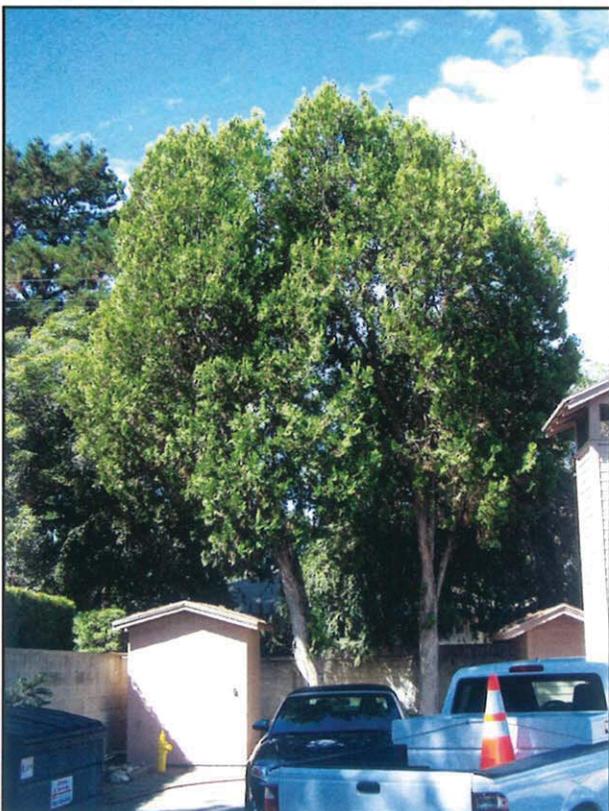
Figure 5. Showing the two Oriental Arborvitae trees which are planned for removal. The new operations building is designed to be built in this location.

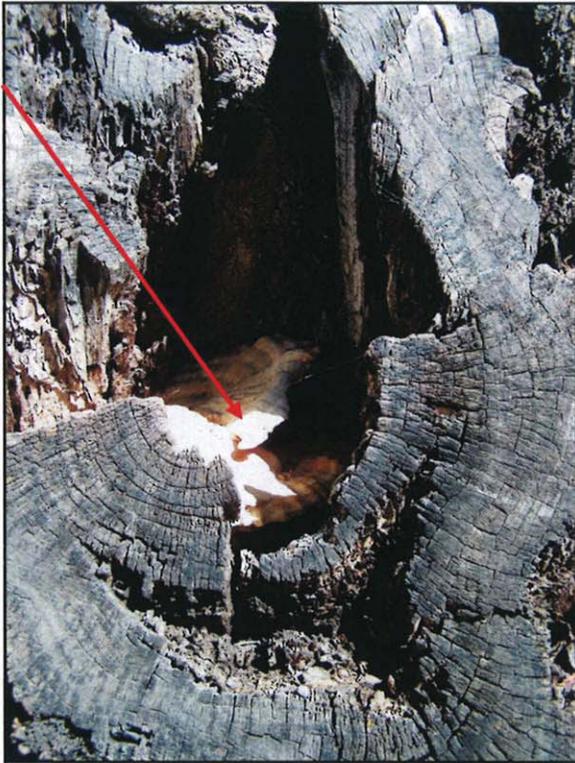
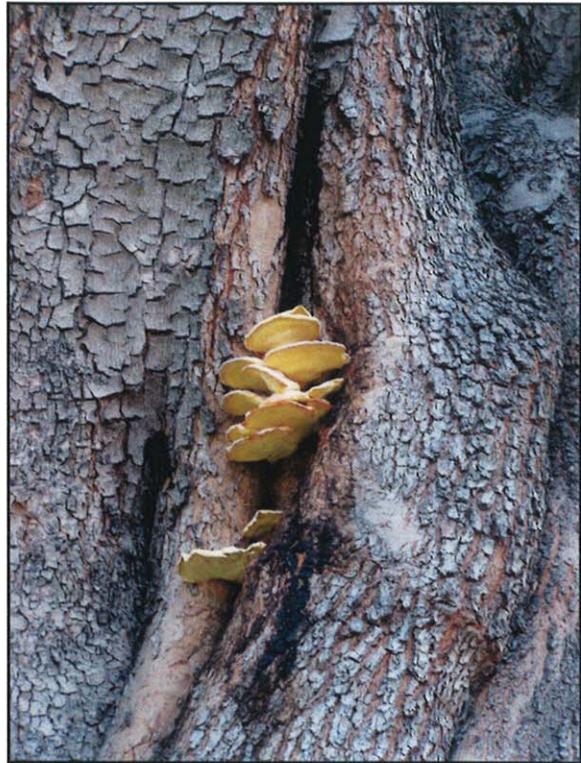
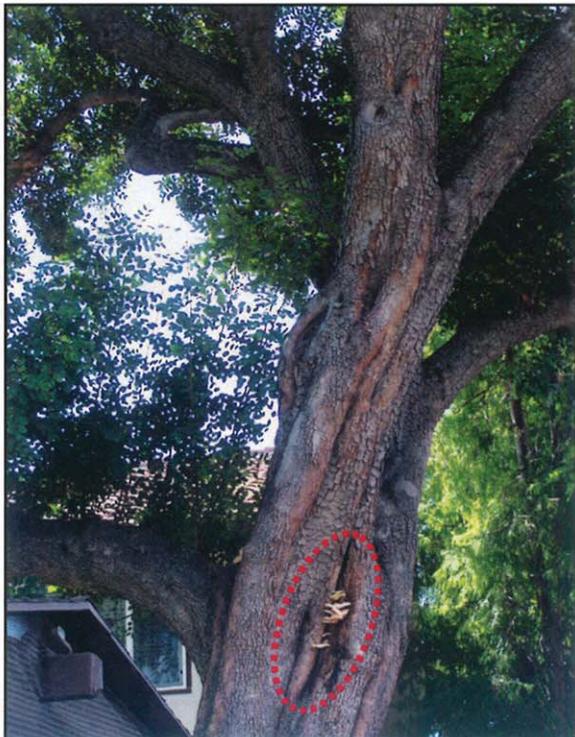
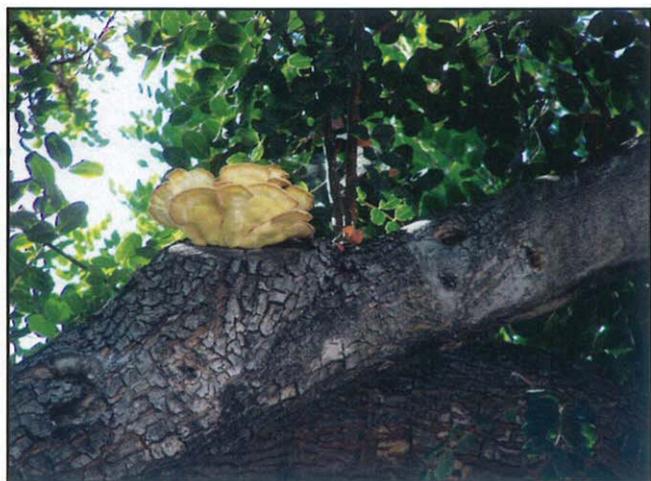
There is one private tree (located in the rear yard area of 541 Adelyn Drive) which could impact the project in that it is considered hazardous due to the presence of a large amount of decay. This tree has visible fruiting bodies (conks) for at least two types of decay fungi: Sulfur fungus (*Laetiporus sulphureus*) and *Ganoderma sp.* These types of fungi cause heart, trunk and butt rots which have obviously spread throughout the entire tree (see Figures 6-9). The new "Metering Facility" is planned to be built directly under the canopy of this tree. If any portion of the tree should fail, this building could be damaged and anyone in the immediate area could be severely injured. Due to the clear hazard associated with this tree, the owner would be well advised to seriously consider its removal.

Figures 6-9. Showing the various fungal growths found on the private carob tree directly adjacent to the driveway entrance. At least two types of decay are confirmed, both Sulfur Fungus and Ganoderma. These are heart rot fungi which have extensively attack and progressed throughout all parts of this tree. Because of this, the tree is a hazard to anyone or anything in the fall path of any part of the tree.

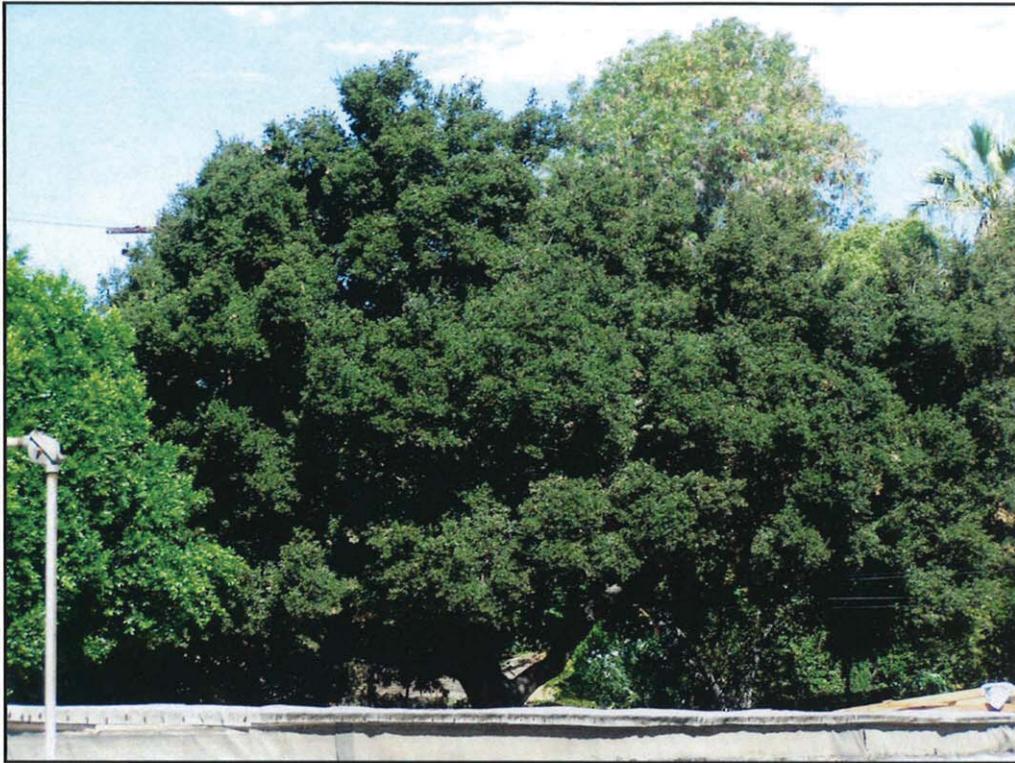
located at the rear of the reservoir near the northwest corner (see Figure 10). This tree is very healthy with great looking foliage, structure, and high vigor. The existing concrete footing is 10 feet from the trunk base and this will be replaced with temporary shoring during the construction process. After completion of the excavation and reconstruction, the final footing will actually be an additional five feet from the tree (see Figure 11).

Figure 10. Showing Tree # 14, a 33 inch diameter Coast Live Oak located near the rear of the reservoir. This tree is very healthy with great structure and high vigor.

Due to the available growth space currently present there is expected to be limited root development within the planned exaction area. However, even if there are roots present, a tree of this size has a vast and far reaching root system which will see little long term impact due to this project. In order to help minimize the expected short term impacts, it is recommended that a temporary protective fence be installed which encompasses as much of the dripline as possible. This area should be kept clear of any and all construction equipment and debris including excess soil. The area within the protective fencing should be appropriately mulched with leaf litter and or wood chips.

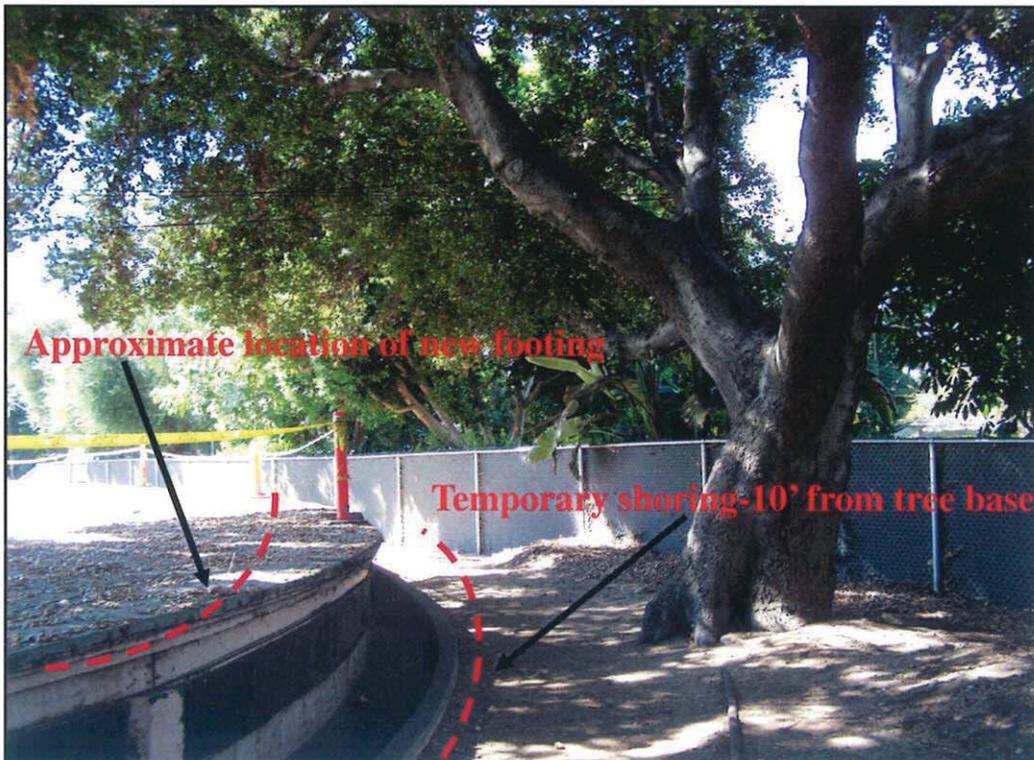
Figure 11. Temporary shoring will be 10 feet from the trunk base very near where the existing concrete is. After which, the new footing will actually be an additional five feet away from its current placement which will increase the space the tree has to grow.

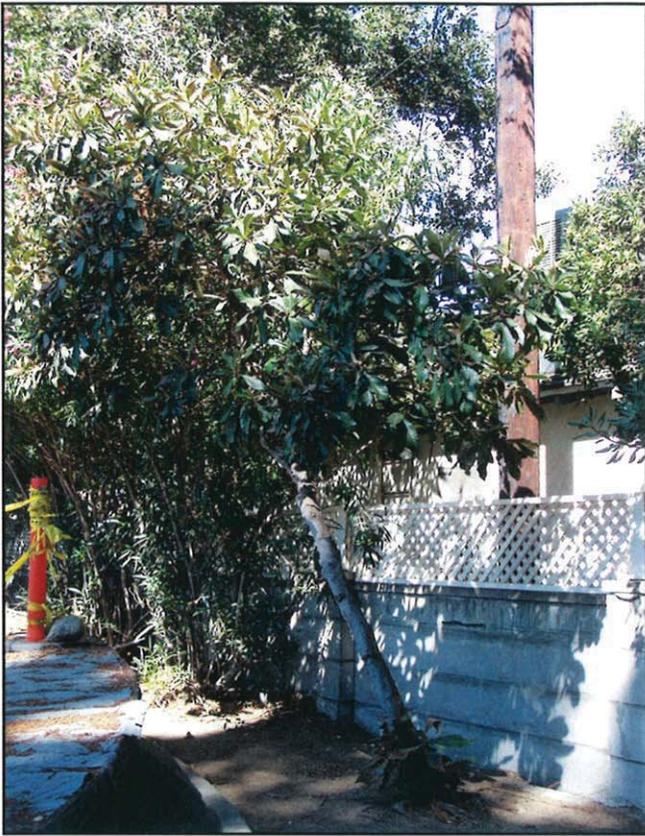
TREE #15: This is an Edible Loquat located directly behind the reservoir. This tree is already struggling as evidenced by the dieback throughout its canopy and very poor vigor (see Figure 12). As reconstruction of the reservoir is not expected to impact this tree, no specific recommendations are given. However, more than likely this tree will continue its downward spiral and may die regardless of what happens adjacent to it. Management may wish to consider replacement of this tree with a new specimen of acceptable species for the area somewhere else on the site.

Figure 12 (at left).
Showing Tree #15, the Edible Loquat located at the rear of the reservoir. Although difficult to see in this photograph, the canopy of this tree is in decline with dead and or dying foliage throughout. The size and location of this tree lessens any potential construction impacts.

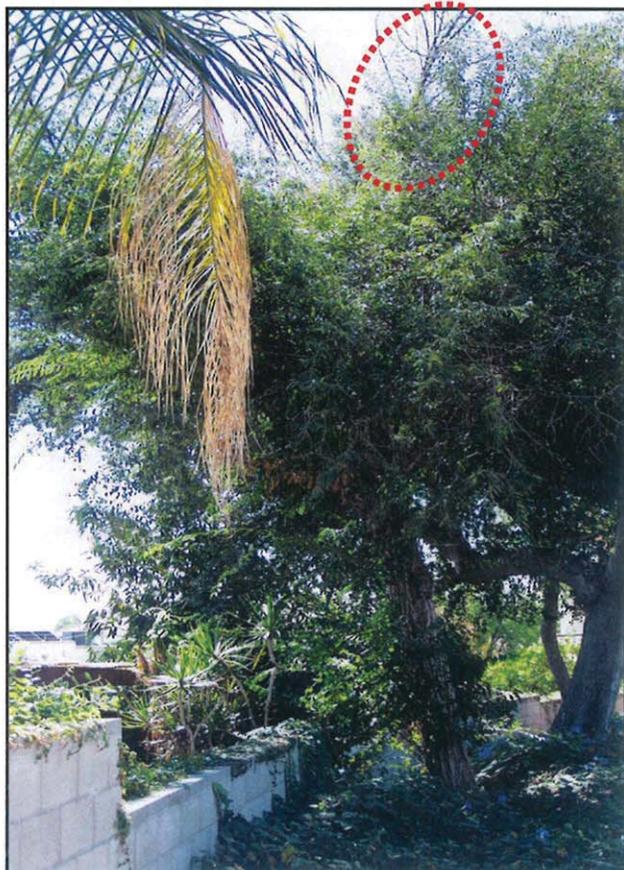
TREE #16: Located on the eastside of the reservoir, towards the back is Tree #16, a Siberian Elm with low to moderate vigor. The canopy of this tree is full of dead twigs and branches, and it is clearly in a state of decline (see Figure 13). However, the planned construction will occur well away from this tree and should not contribute to its continued poor health. It is recommended that the tree be pruned in order to remove the dead material and help encourage new, healthy foliar development.

Figure 13 (at right).
Showing Tree #16, a Siberian Elm located at the rear, east side of the reservoir. The canopy of this tree is also in a state of decline with dead twigs and branches throughout. This tree is located at a good distance from the current concrete footing and construction impacts are expected to be minimal.

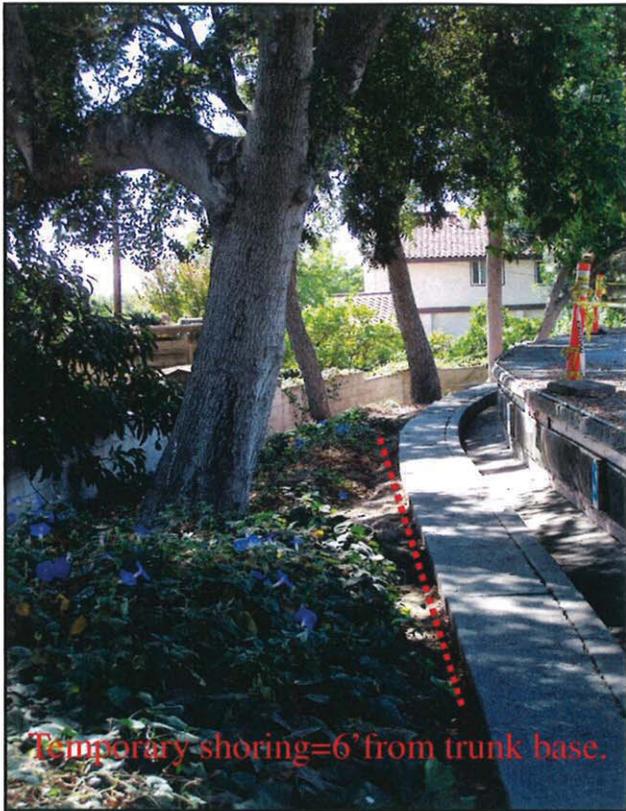
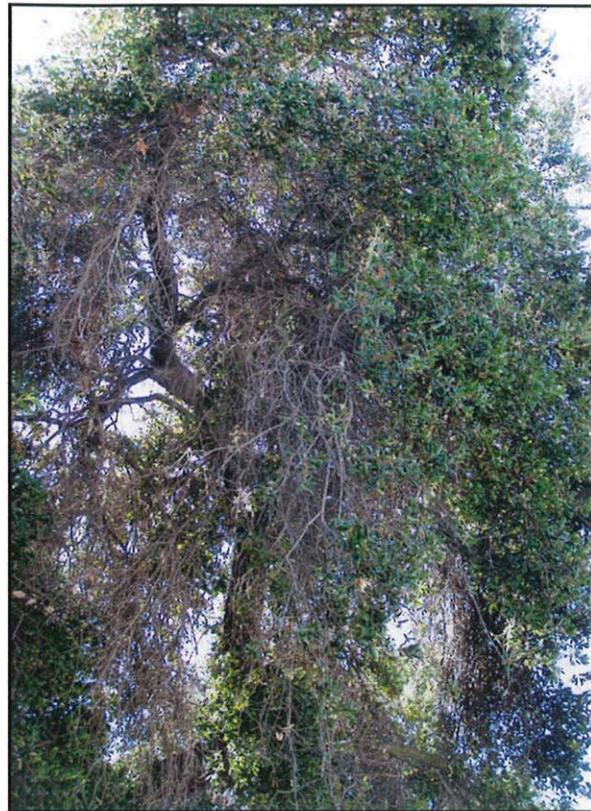
TREE #17: The second oak on the site is identified as Tree # 17 and it is also located on the eastside of the reservoir. Currently the concrete footing sits approximately 6 feet from the trunk base and this is where the temporary shoring will be installed (see Figure 14). There is already canopy wide twig dieback, indicating moderate to low vigor (see Figure 15). This tree is leaning slightly out over the reservoir, which means that most of the large supportive roots will be present on the back side of the tree. Any trenching along the concrete edge will encounter a few feeder roots, but the majority of the root system is most likely located in the landscaped area surrounding the tree. Due to the direction of growth, pruning should be done which appropriately raises the canopy to accommodate construction equipment. As with the other trees, protective fencing should also be installed around this oak to ensure as much of the root system as possible is left undisturbed.

Figure 14 & 15 (above). Showing Tree #17, a 21 inch diameter Coast Live Oak on the eastside of the reservoir. This tree is of moderate vigor, with dead twigs throughout the canopy. The oak is 6 feet from the current footing, and will have temporary shoring installed in this location. The tree is leaning slightly toward the facility, which means that most of the large support roots are to the rear of the tree and root loss is expected to be minimal. Prune out dead wood and install protective fencing.

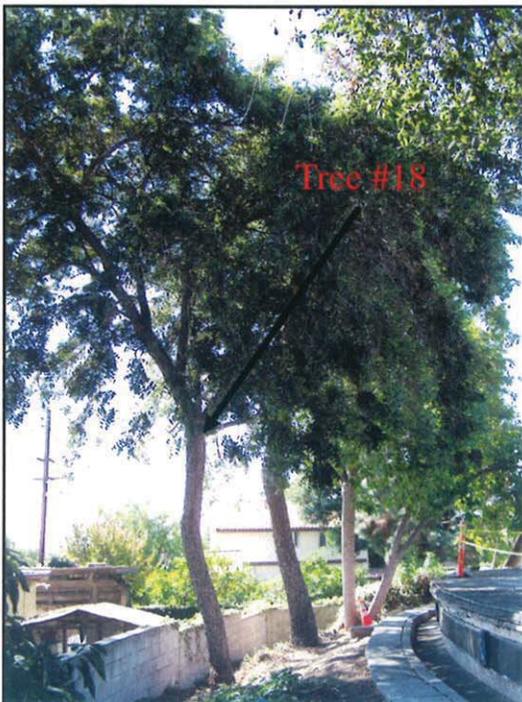
TREE #18: This next tree is a Pecan and it is located on the eastside of the reservoir as well, on the downward portion of the slope area (see Figure 16). There is some twig dieback in the

canopy, but otherwise the tree looks really good, with moderate vigor. The base of the tree is 15 feet from the concrete footing and no adverse impacts are expected from the reconstruction project. The only specific recommendations offered here are to prune out the dead twigs, and be sure that soil does not accumulate around the trunk base.

Figure 16 (at left).
 Showing Tree #18, a Pecan tree located 15 feet away from the current concrete footing. Reconstruction of the reservoir is not expected to have any adverse impact on this tree. The only specific recommendation would be to ensure that soil debris does not accumulate at the bottom of the slope thereby burying the trunk base.

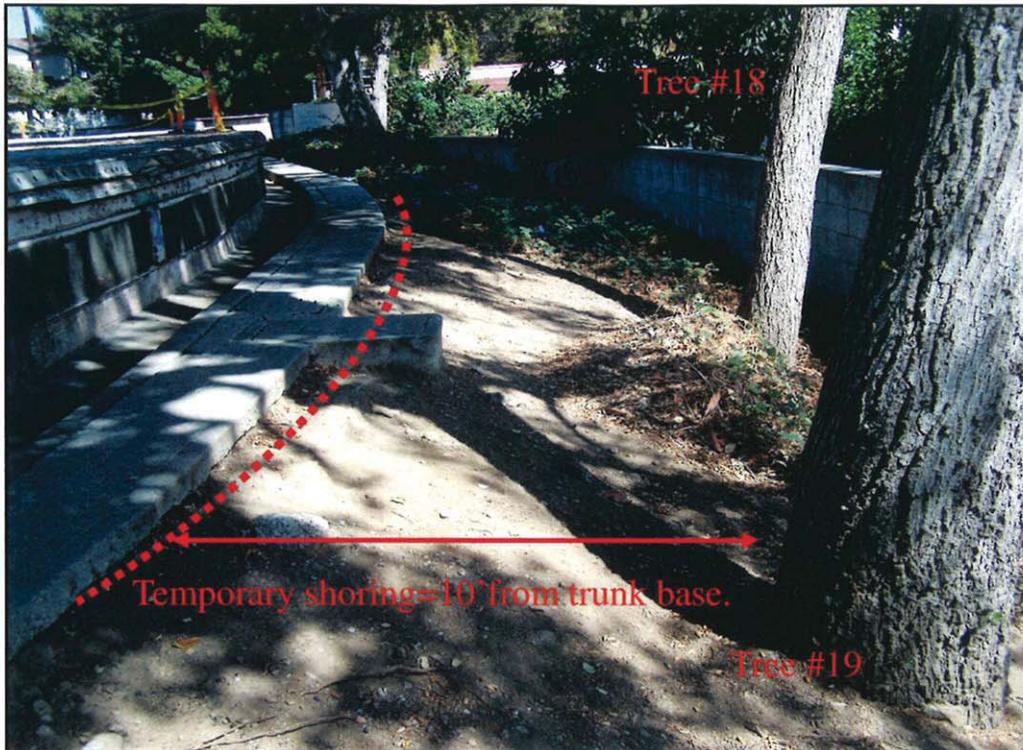
TREE #19: The last oak on the site, this tree has a trunk diameter of 17 inches and is located 12 feet away from the current concrete footing (see Figure 17). This tree has only moderate to low vigor with canopy wide thinning and dieback. The majority of the canopy is distributed over the dirt planting area with limited leaf litter accumulation. Due to the canopy placement, the “dripline” can easily be protected by installing appropriate fencing. It is recommended that an organic mulch layer be placed within the protected area and that all dead material be pruned out. As with all the trees being retained on this project site, this oak should be monitored for any change in health.

Figure 17 (above). Showing the placement of the temporary shoring as it relates to Tree #19. This 19 inch diameter Coast Live Oak tree sits 12 feet from the current concrete footing. Temporary shoring will be installed according to plan details and should have no adverse impact on the long term health of this oak tree. The majority of the canopy is over the landscaped area and protective fencing can easily be placed in such a way that the root system and trunk base are not impacted.

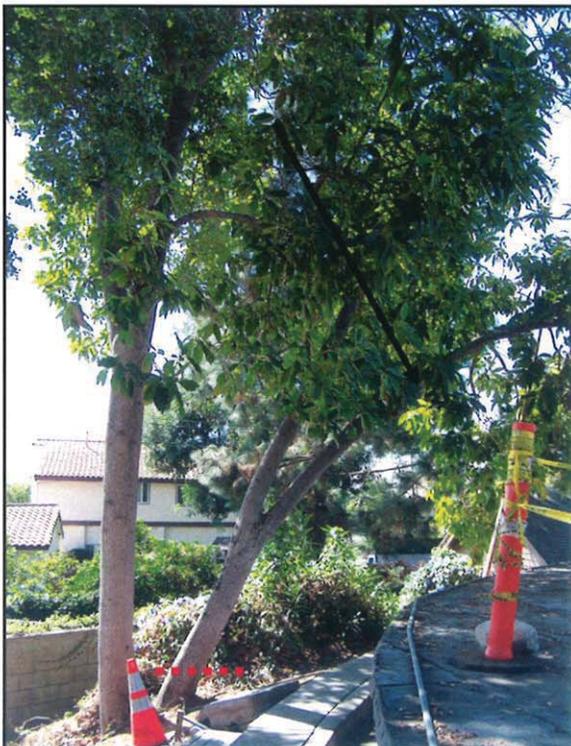
TREE #20: This last tree is a double stemmed Avocado of which one of the stems leans heavily over the roof of the reservoir (see Figure 18). The tree itself is very health with high vigor and good crop production. The only real issue is whether a portion of the tree will need to be removed. Due to the lean, it may be necessary to remove the secondary stem in order to accommodate construction equipment. This can be done, if absolutely necessary, without affecting the overall health of the main stem, as these two are not dependant on each other for any resources.

Figure 18 (at left).
 Showing Tree #20, a double stemmed Avocado. This tree is in really good health, with high vigor and is currently producing a large crop of fruit. If possible, remove only the branch indicated first to see if this is adequate to accommodate construction equipment and new footings. Due to the positioning of the secondary stem, it may be necessary to remove it entirely at the base. Although this will be contribute to a loss of productivity, the main stem should be able to compensate and grow additional limbs to fill the void.
