October 6, 2010

RE: 545 W. Adelyn Drive- Wilson Reservoir

Wilson Reservoir-Tree Data

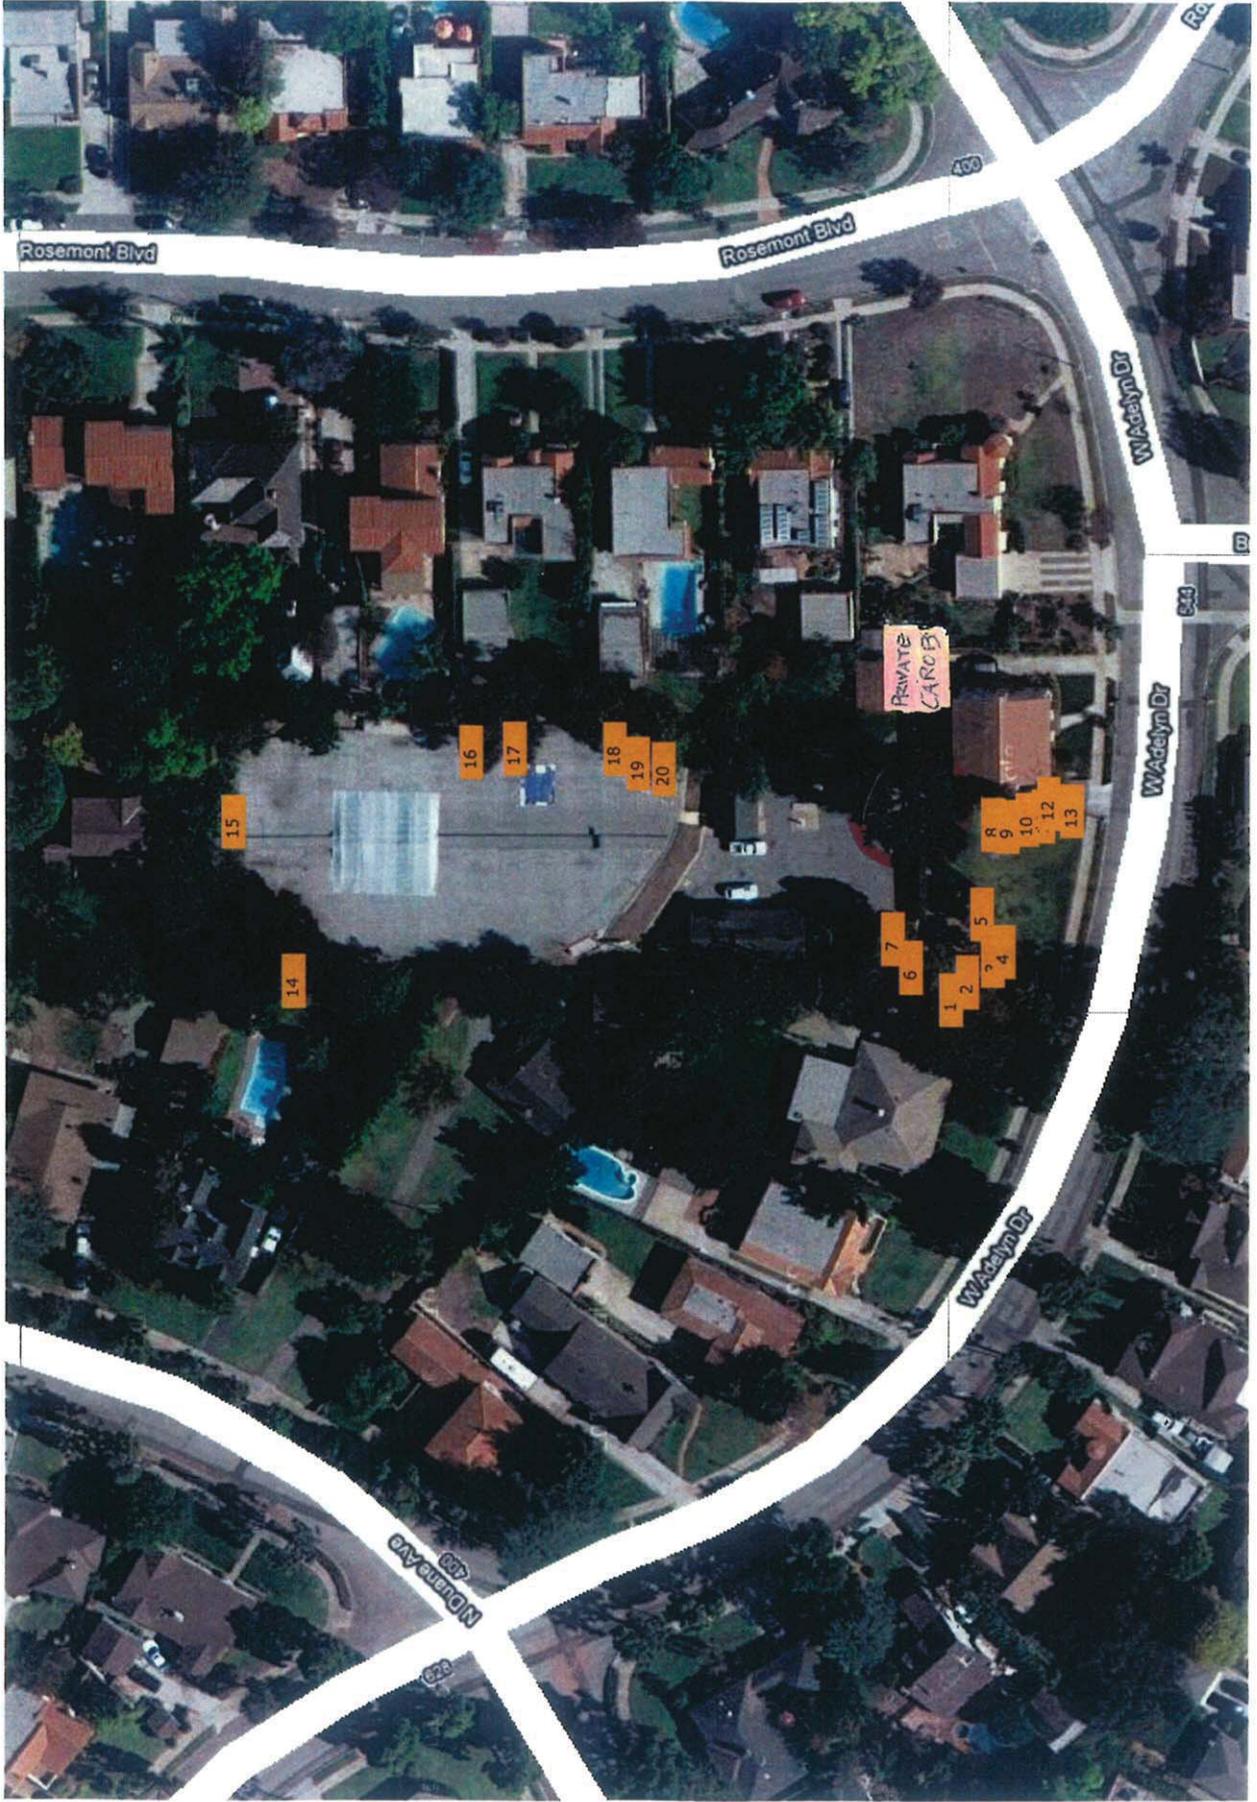
Inventory Map

OBSERVATIONS: The entire reservoir site is being rebuilt due mostly to age related issues, the plan details call for the removal of seven trees near the front of the property. These include 5 Victorian Box trees and 2 Oriental Arborvitaes. The remaining trees consist of the 6 Bald Cypress trees along the driveway entrance, and 3 Coast Live Oaks, 1 Avocado, 1 Pecan, 1 Siberian Elm, and 1 Edible Loquat located around the perimeter of the existing reservoir (see attached aerial photograph for positions, page 7).
